RESPONSE OF BURIED VERTICALLY ORIENTED CYLINDERS
TO DYNAMIC LOADING

GAYLE E. ALBRITTON, ~~AND~~ AND JIMMY P. BALSARA
U. S. Army Engineer Waterways Experiment Station
Vicksburg, Mississippi 39180

JUN 1980

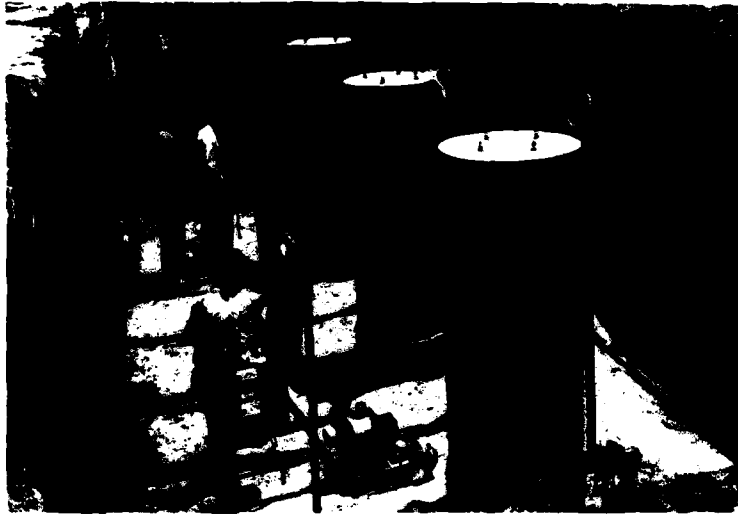
Figure 2. Cylinders placed on foundations

The three DEOT test beds were excavated to 3.05 metres (10 feet) deep, the structures placed, and then backfilled with clean, dry sand. After a test bed was excavated, circular foundation blocks with hold down rods were placed in the bottom of the bed on preleveled surfaces. The vertical cylinders were then placed on their foundations (Figure 2) and instrumentation connections made. The dry sand was placed in 15.2-cm (6-inch) lifts with each lift receiving three vibration passes (Figure 3) to obtain the desired density of 1681 kg/m^3 (105 pcf).
